Sabbatical Leave Report

Darrow Soares

Spring Semester 2003
Spring Semester 2004

Sabbatical Leave Proposal for the 2002-2003 School Years
Darrow Soares
Air Conditioning and Refrigeration

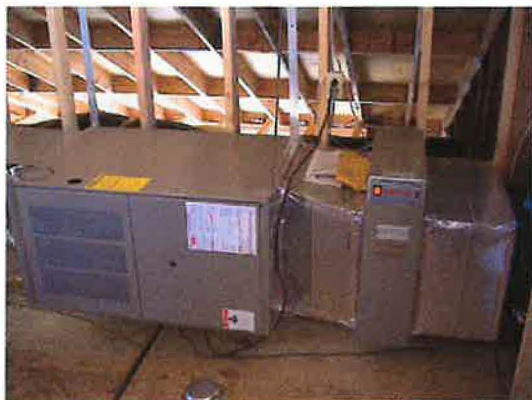
Horizontal furnace installed in the attic

City inspection of the air conditioning equipment resulted in few changes. The Uniform Mechanical Code UMC 908.0 put the furnace clearances in question. The code violation was resolved by extending the flooring out in front of the furnace. In addition, the inspector questioned if the ducts were attached based on UMC 1601.3.1. This code requires that all duct joints be air tight. The inspector requested that insulation be removed at specific duct joints in order to see if the ducts were properly attached with band clamps. The joints passed inspection, but he

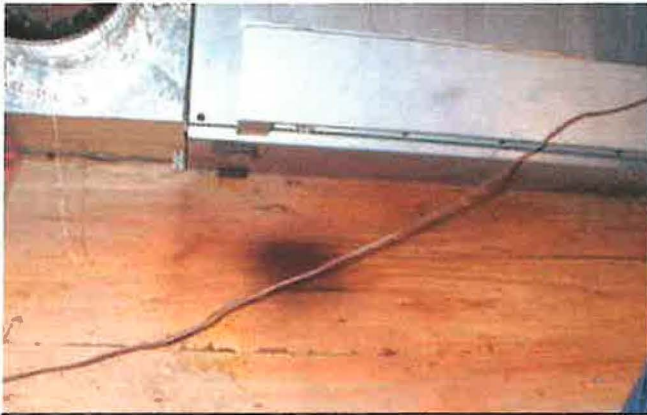
The Bender furnace showed signs of flame roll-out caused by a cracked heat exchanger

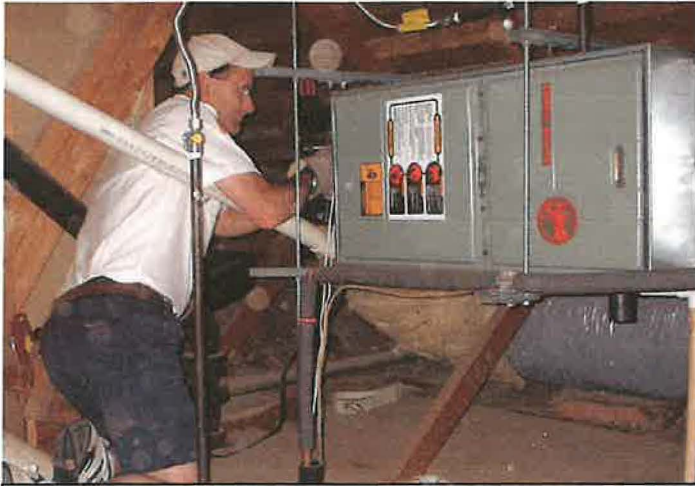
The Bender replacement furnace was hung away from combustible material

Corydon and Bender furnaces allowed this type of installation. The Gant and Habitat furnaces remained on their wood platforms, as allowed by the Uniform Mechanical Code.

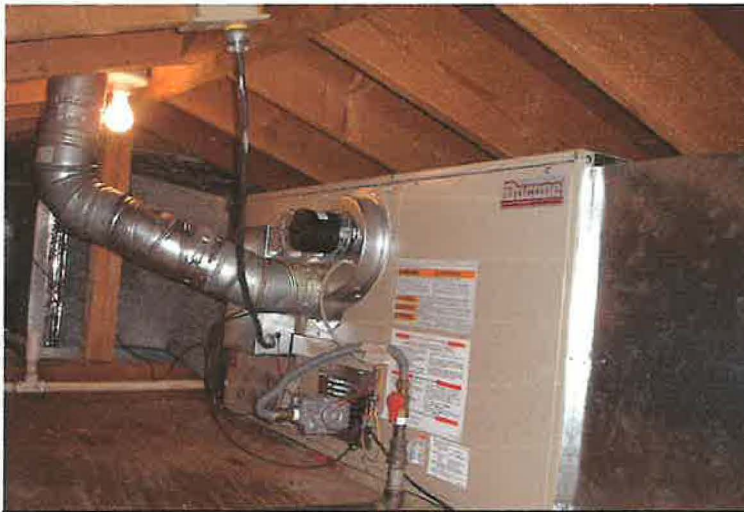
The Gant attic space was too confined to hang the replacement furnace

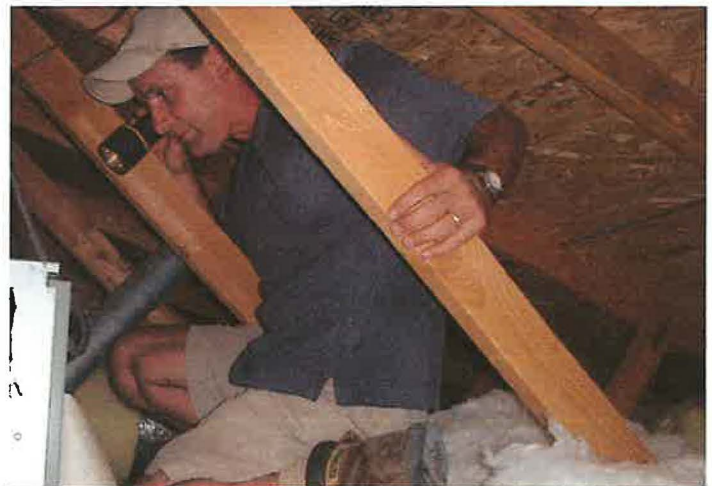
Checking flame conditions for ruptured heat exchanger

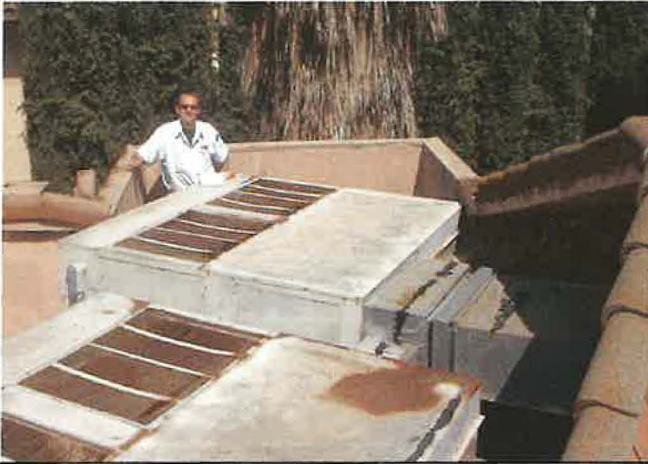
Two ten ton package units served the sanctuary at the First Methodist Church in Walnut, CA.

- two 10 ton 120,000 Btu/hr Lennox package heat pumps
- two 7.5 ton 90,000 Btu/hr Lennox split heat pumps

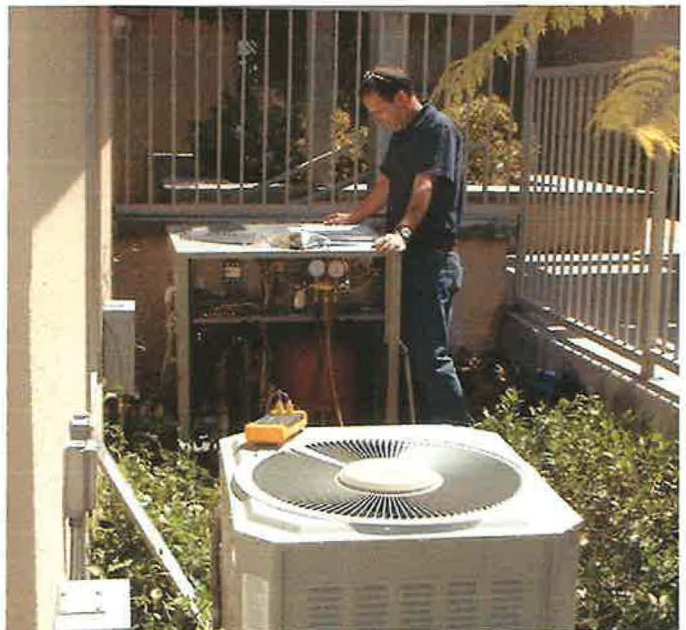
Two 3 ton air conditioners are checked for saturation temperatures, superheat and subcooling.

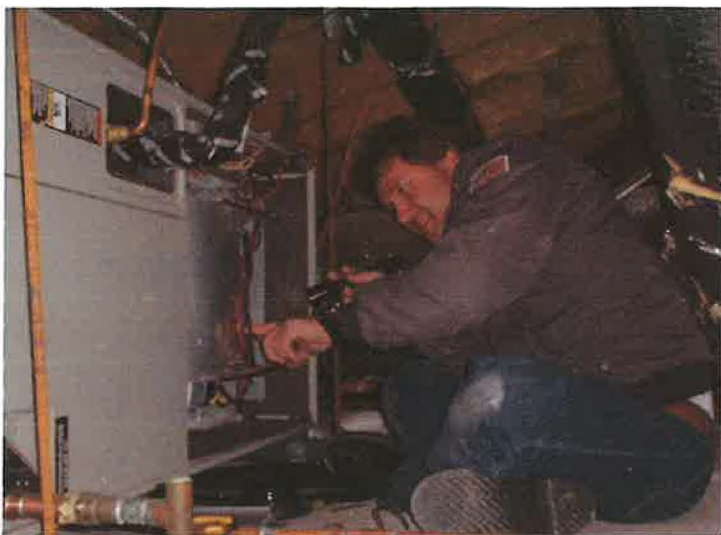
Service Manager Ralf Kies prepares to measure wet and dry bulb temperatures across the air handler.

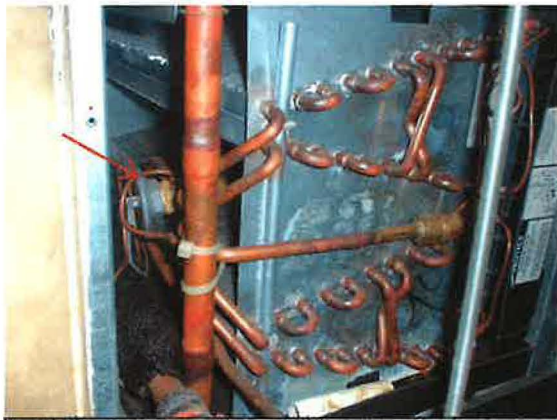
The metering device is often deep in the equipment and difficult to repair.

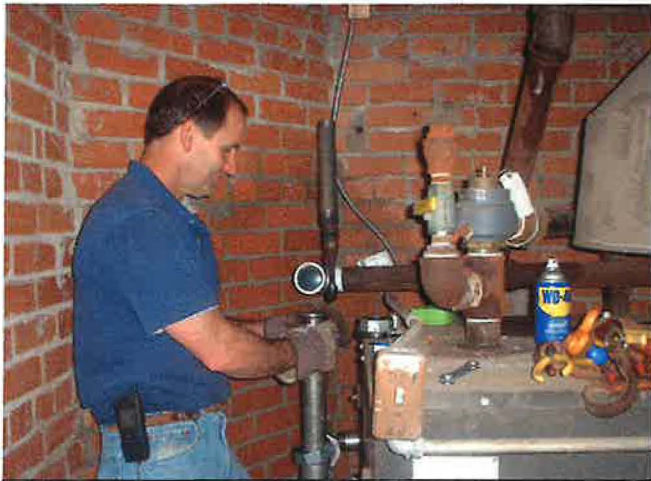
Preparing to replace a check valve and install a condensate pump and receiver

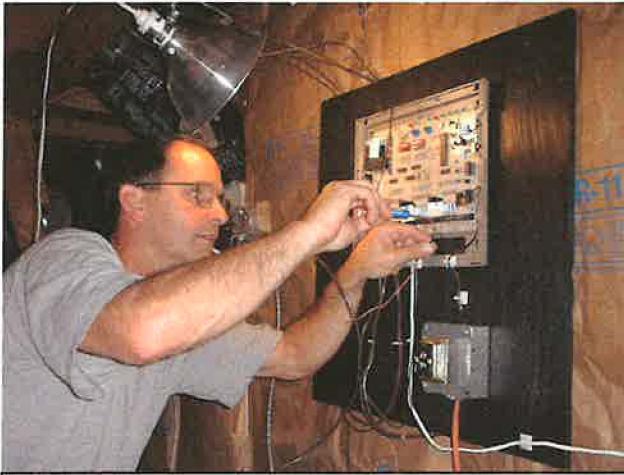
Zone thermostats are connected to the TZ-4 control panel

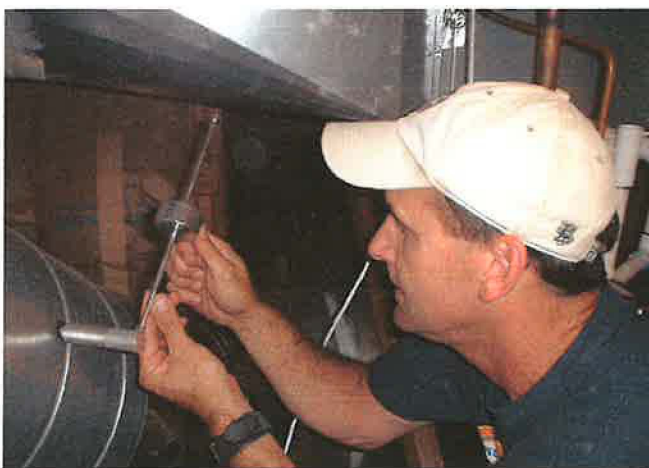
The counter weight is set on the bypass damper

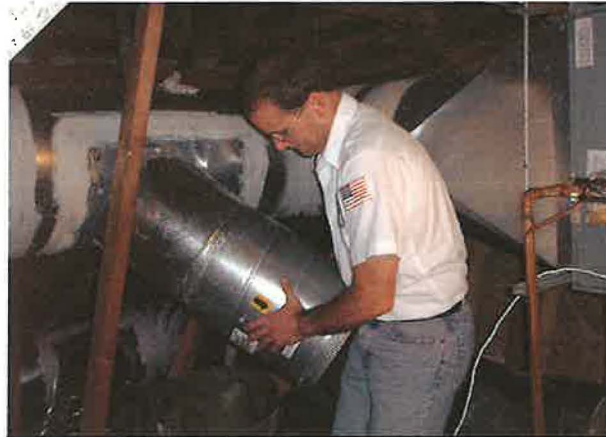
The bypass damper is installed in the supply duct to relieve duct pressure during low loads

cold supply air directly into the return and reduce the loading effect on the evaporator. The opposite would occur in the heating mode; hot air from the supply plenum would by pass into the return, sending heat exchanger temperatures soaring. As a result, discharge air temperature sensors (DATS) are required in by-pass zoning applications. A discharge air sensor guards against freeze up of the evaporator coil in the cooling mode and excessive operating temperatures in the heating mode.

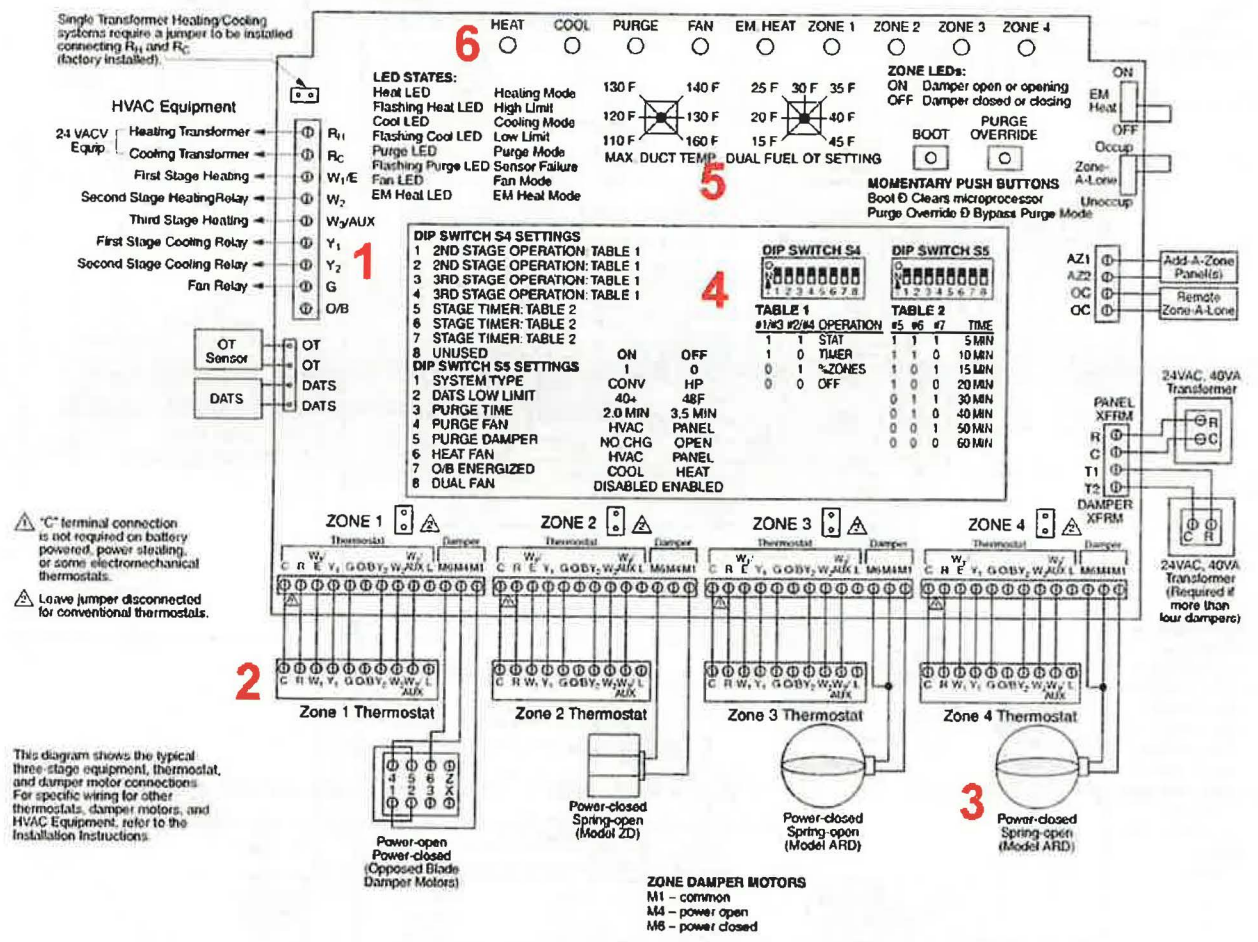
Methods of wiring equipment, thermostats, dampers and DAT to TZ4 control panel. References include: 1 Terminals for equipment functions. 2 Terminals to zone thermostats. 3 Junctions for zone dampers. 4 DIP switch banks 4 and 5 to establish system function. 5 DATS high-limit temperature dial. 6 LEDs to indicate mode of operation and zones calling for heat or cool.
